## Material Conditions Series

Each post in the series provides an in-depth look at one of the standard conditions we encounter and document during inspections of buildings and civil structures.

## Part 1: Cracks and Crack Systems in Masonry

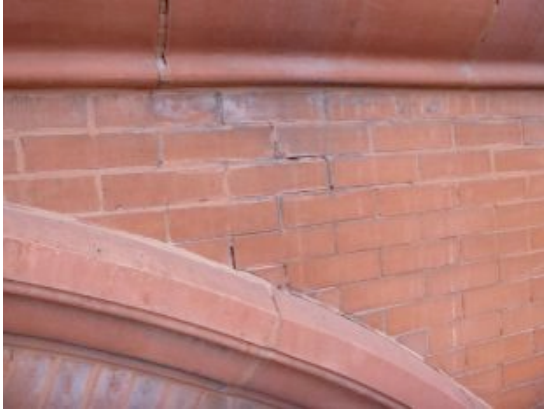
Crack system through joints in brick

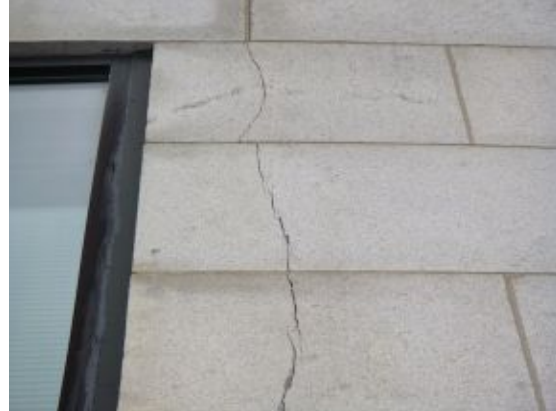
Crack system through units in granite

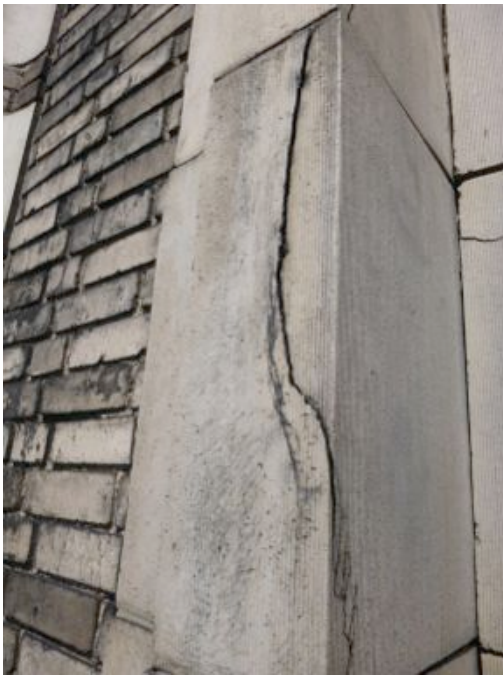
Severe crack through a terra cotta unit

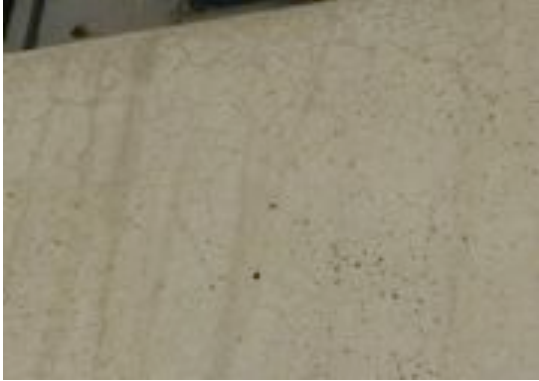
Crazing in concrete

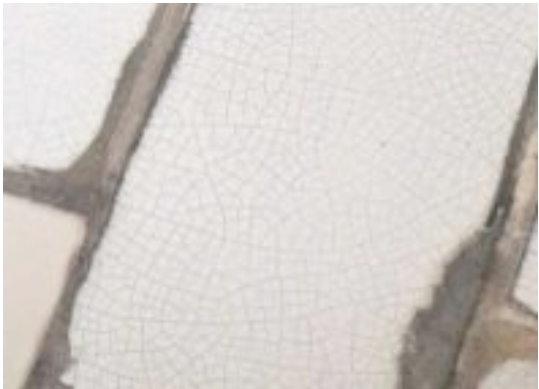
Crazing in a glazed terra cotta tile

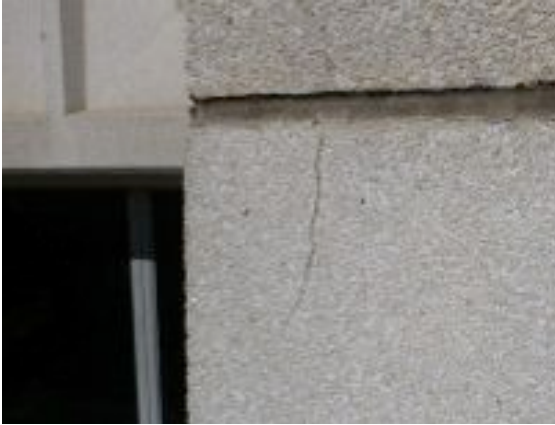
Incipient spall in concrete

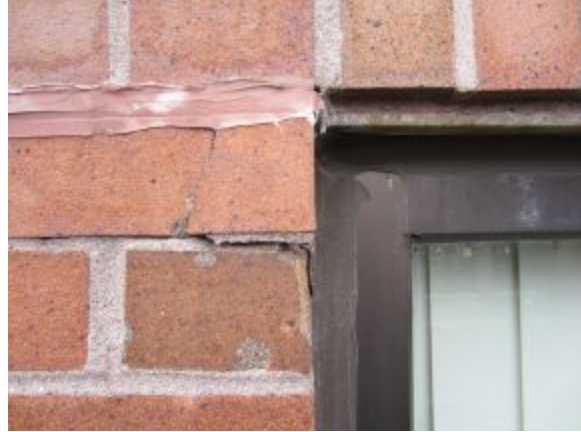
Bonded brick spall held in place by sealant

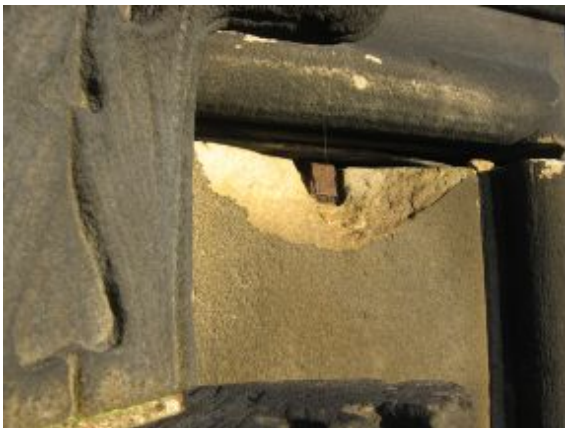
Cramp spall in limestone due to rusted steel anchor

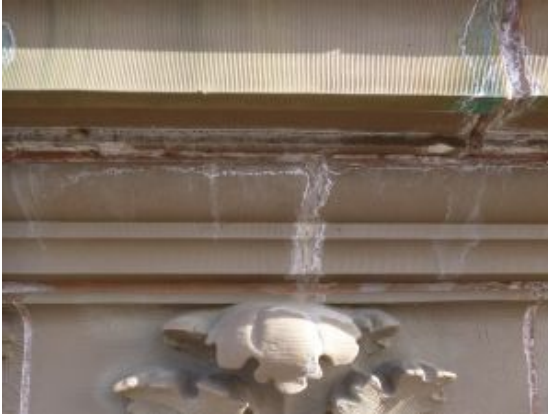
Leached salts in terra cotta

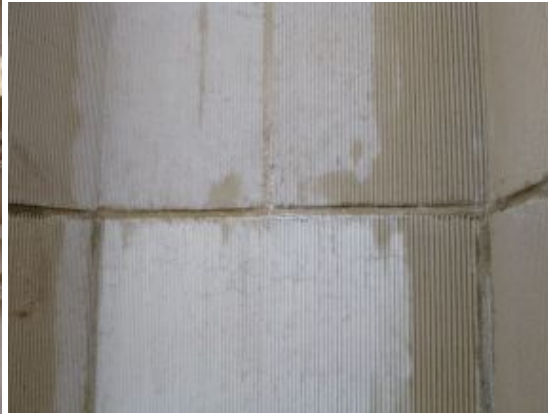
Efflorescence in cast stone

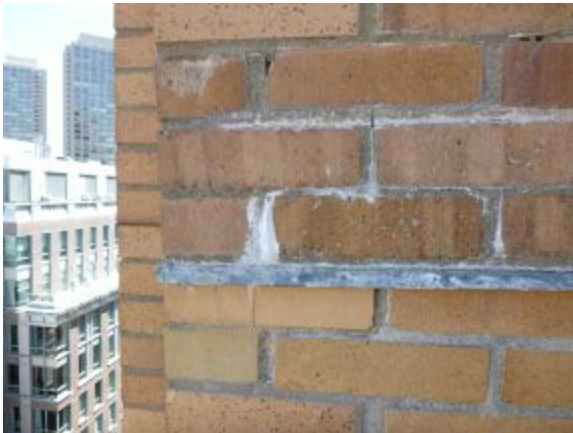
Leached salts at mortar joints in brick

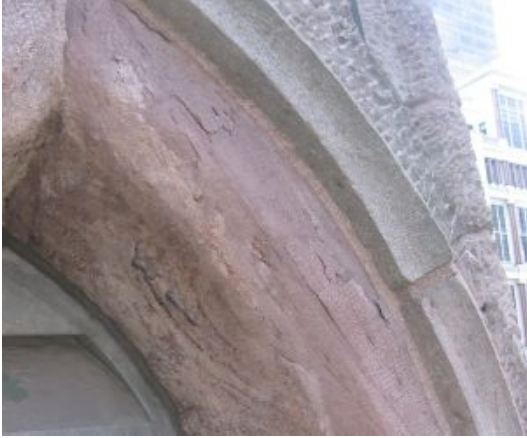
Delaminated sandstone

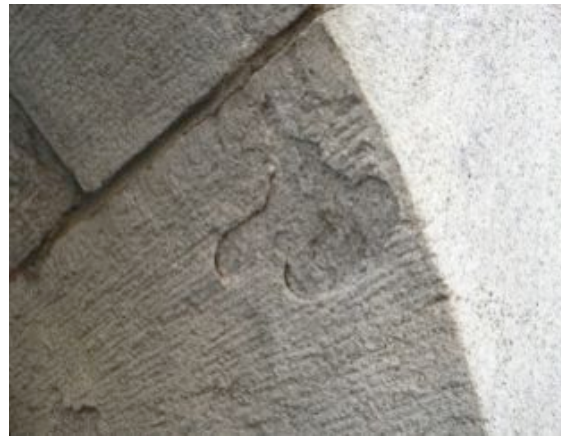
Exfoliated granite

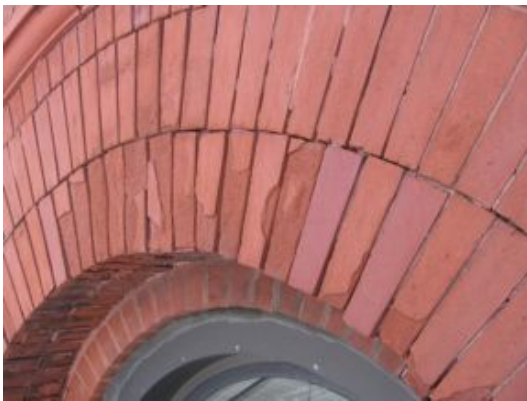
Face-spalled brick, above

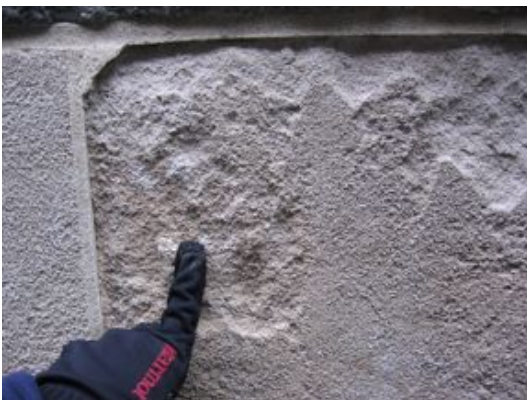
Eroded limestone

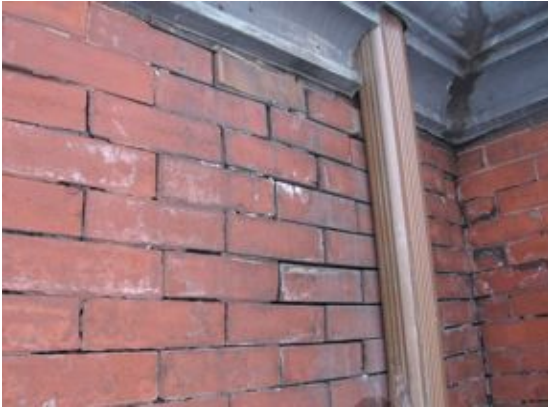
Missing mortar in brick masonry

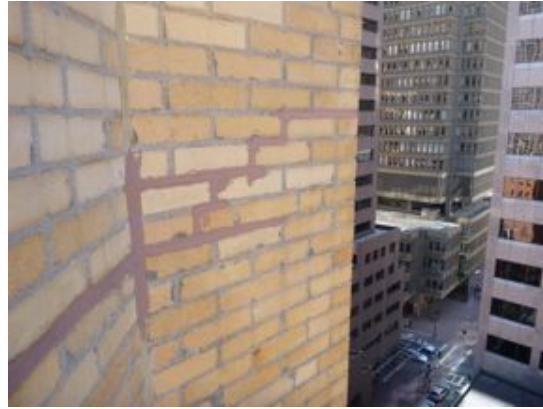
Caulked mortar joints in brick masonry

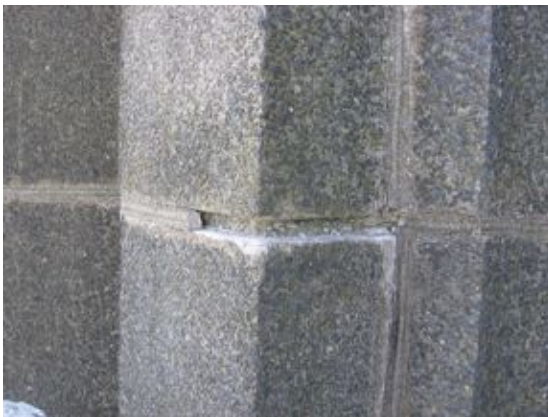
Failed mortar in cast stone masonry

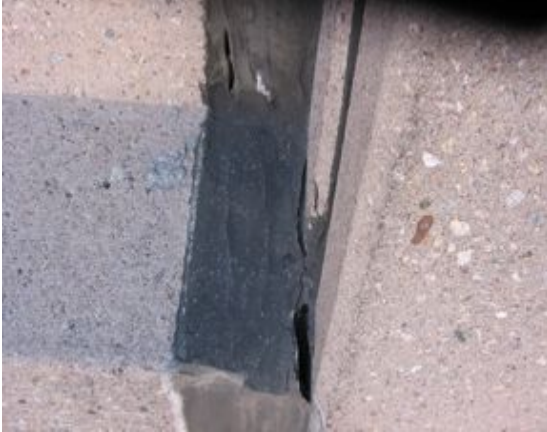
Failed sealant at an expansion joint in precast concrete panels

The service life of sealants and caulk is much shorter than that of mortar; these materials deteriorate relatively quickly and must be replaced as part of regular building maintenance.

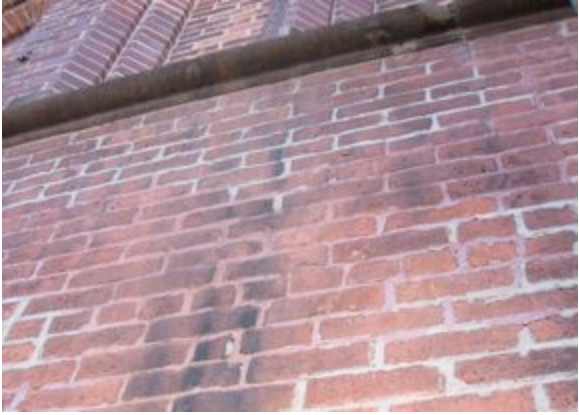
Atmospheric soiling on brick

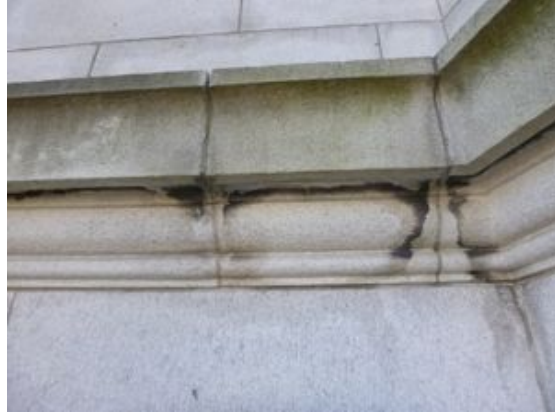
Black crusts on granite

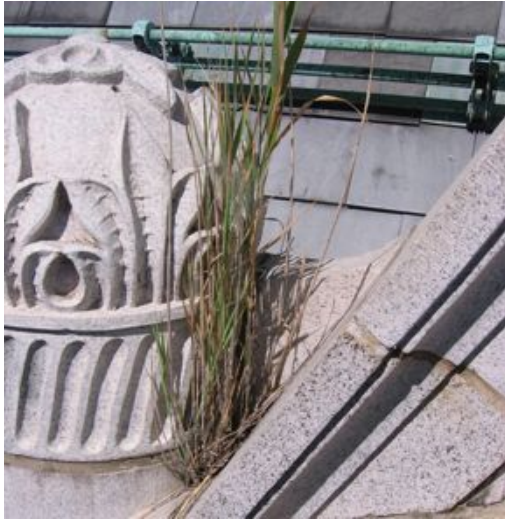
Unintended “living walls”: vascular plant growth in terra cotta

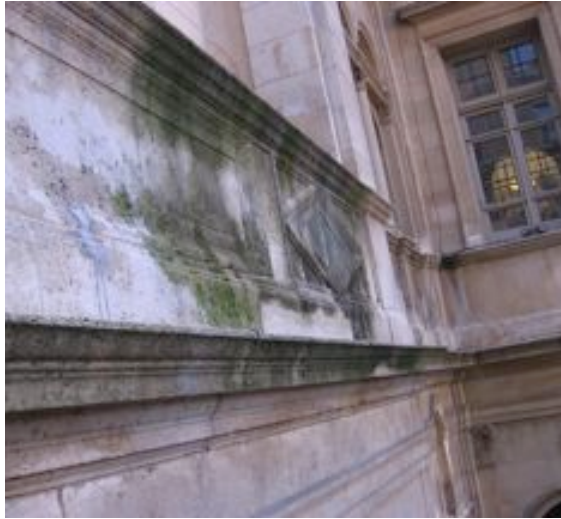
Microbiological plant growth on limestone

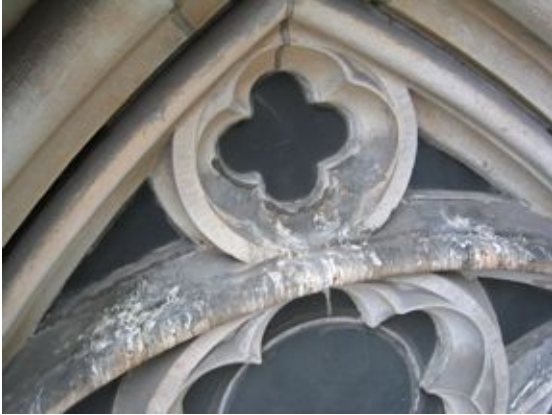
Guano accumulations on marble

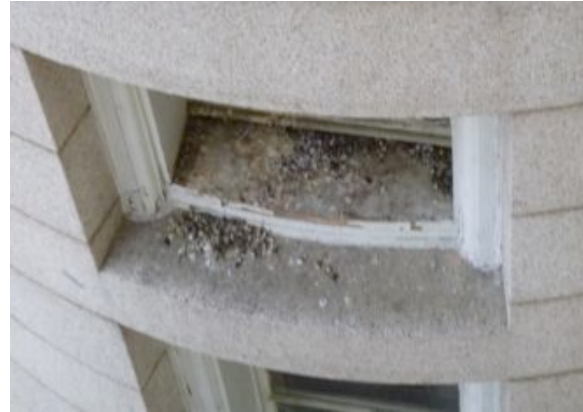
Guano accumulations on granite

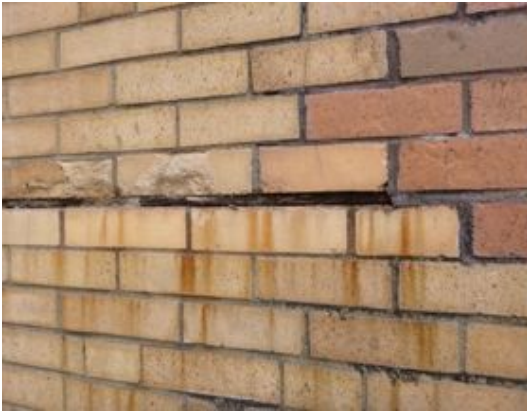
Pack rust in a relieving angle causing adjacent brick to spall

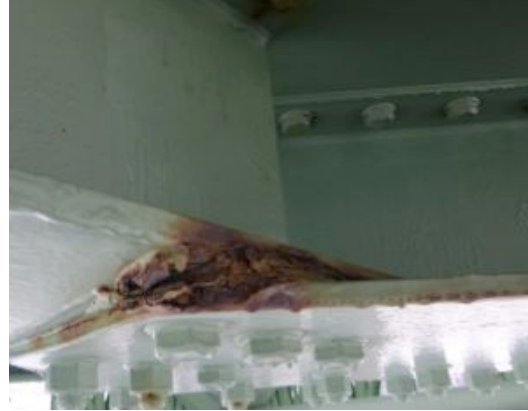
Pack rust between steel plates of a bridge truss

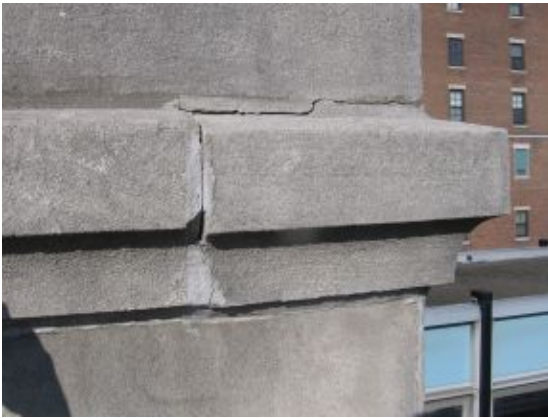
Horizontal and vertical displacement in limestone

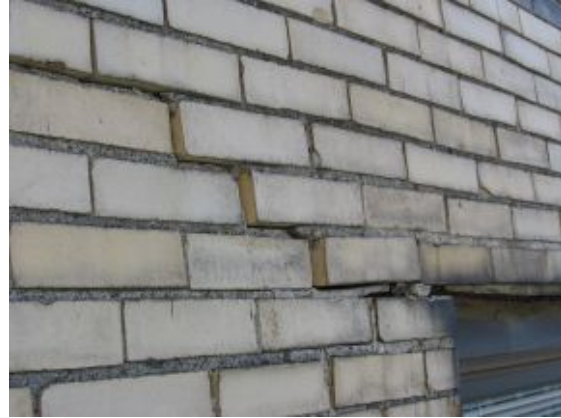
Horizontal and vertical displacement in brick

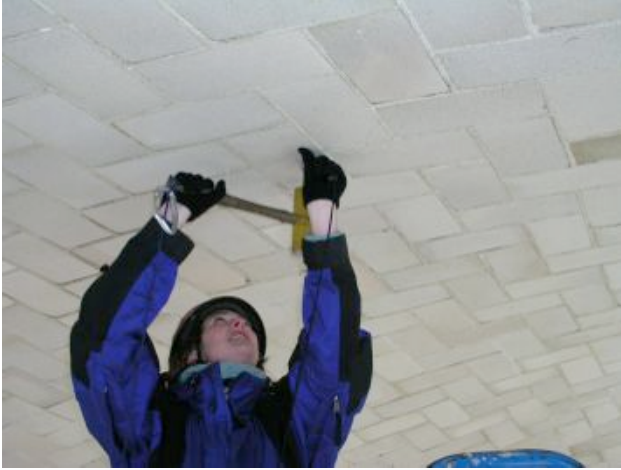
Hammer-sounding a Guastavino tile ceiling

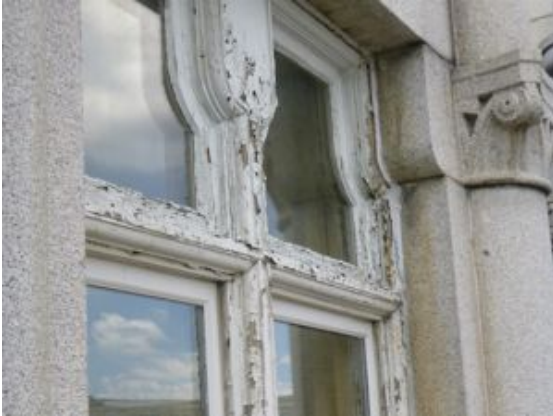
Failed paint coating on wood

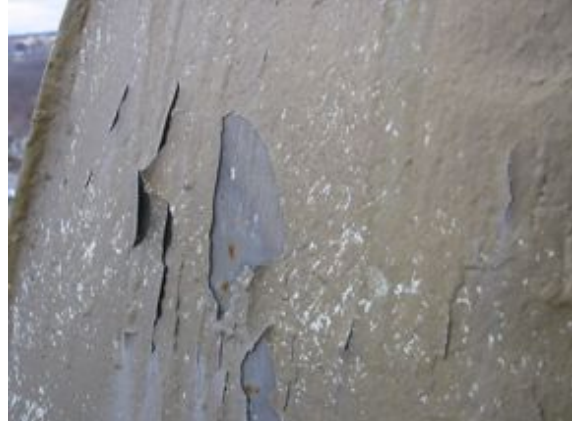
Failed paint coating on sheet metal

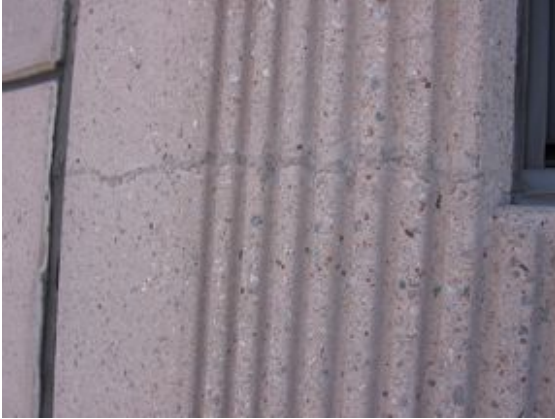
Sound crack repair in precast concrete

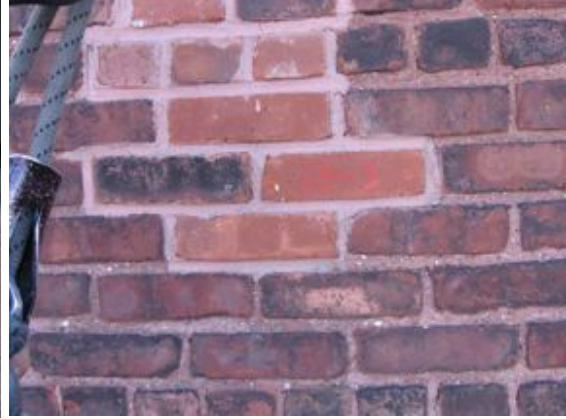
Replacement repair in brick

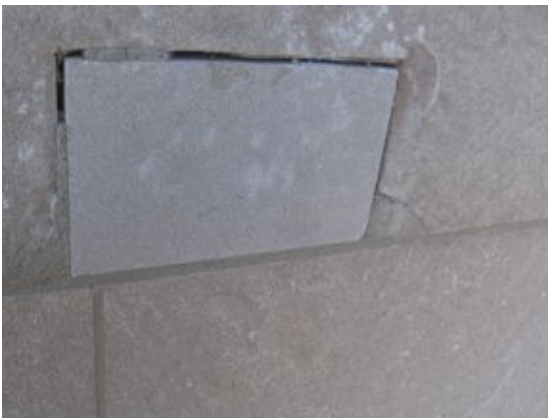
Failed dutchman repair in limestone

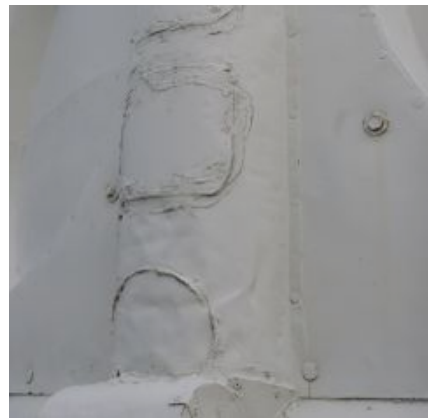
Sound patch repair in sheet metal

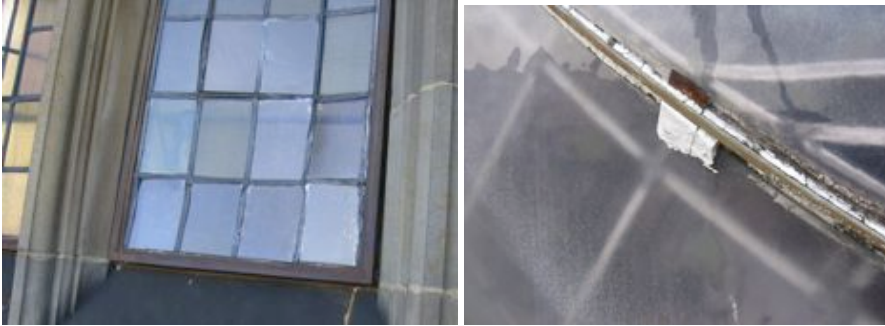
Bulged glass panes in a multi-light window      Putty failure in window glass

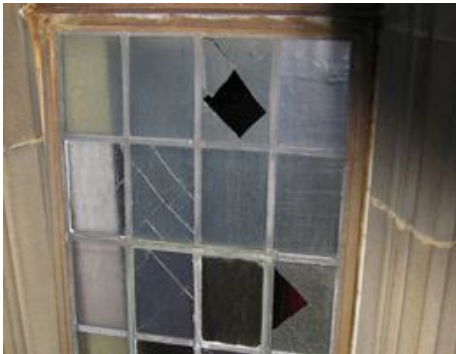
Cracked, loose and missing glass in a multi-light window

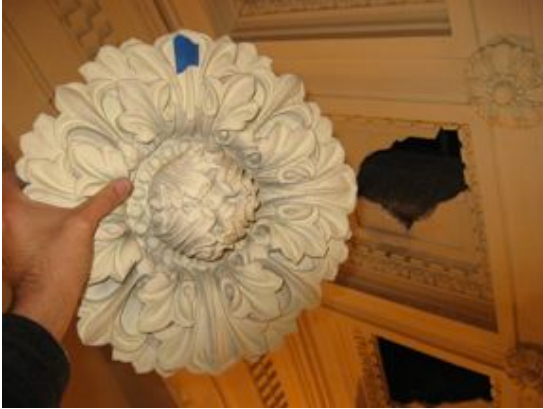
Unsecured plaster medallion

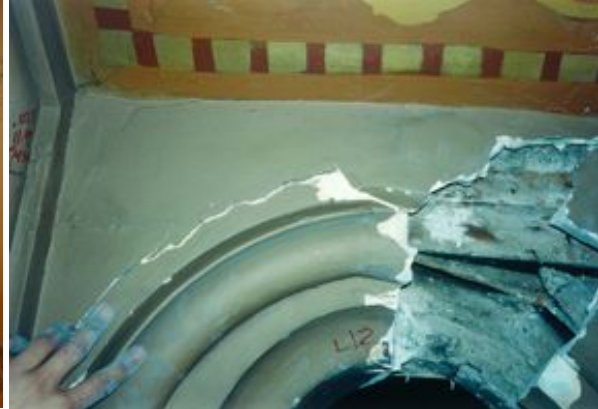
Water-damaged plaster that has separated from the substrate

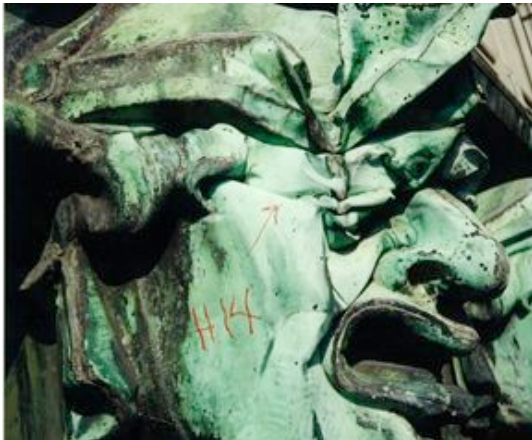
Dented sheet metal grotesque

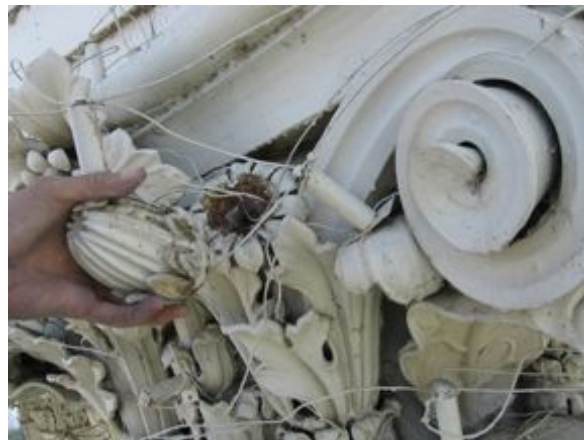
Unsecured cast iron ornament

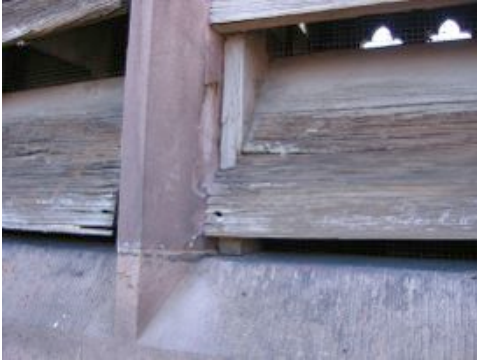
Weathered wood louvers

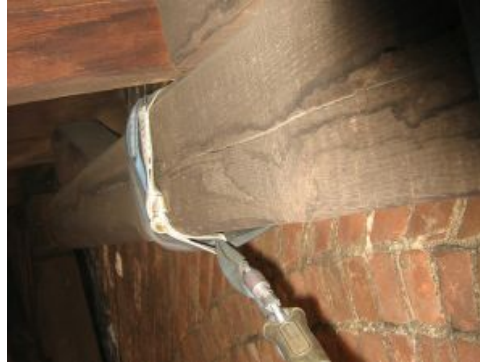
Checked structural wood member

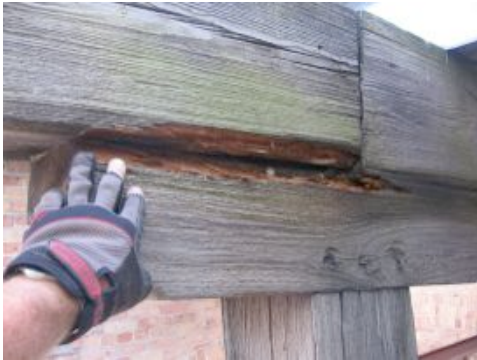
Structural wood members exhibiting biological growth (algae) and rot

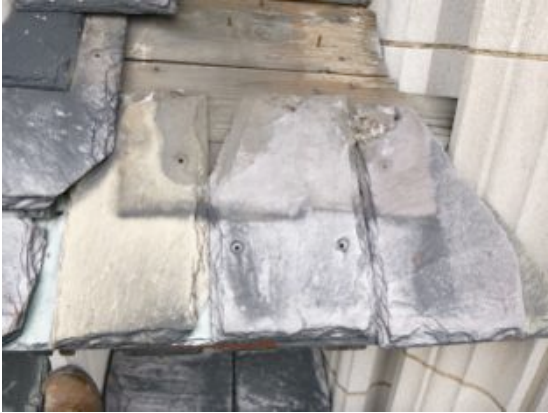
Failed fasteners and missing slates

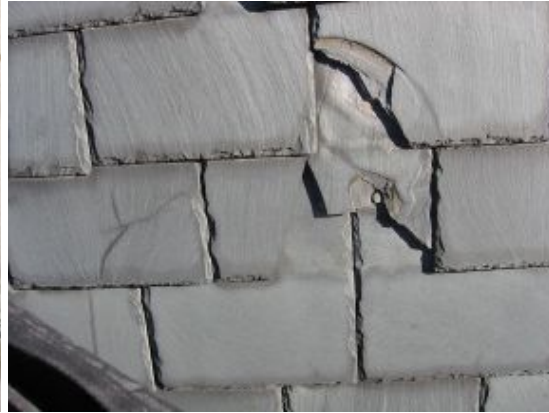
Cracked and missing slates

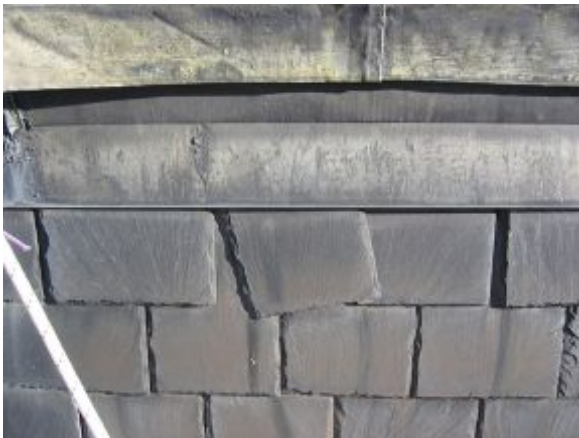
resulting from a failed fastener

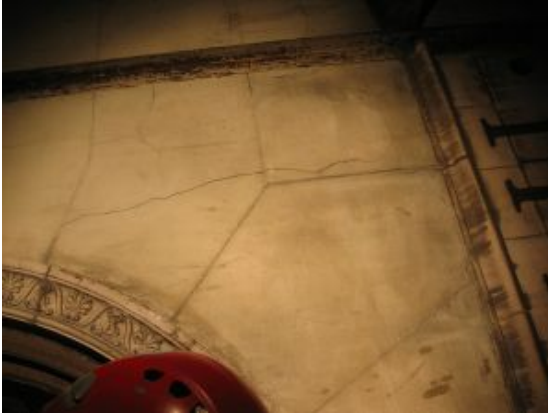
Cracks through stucco scored to imitate stone masonry

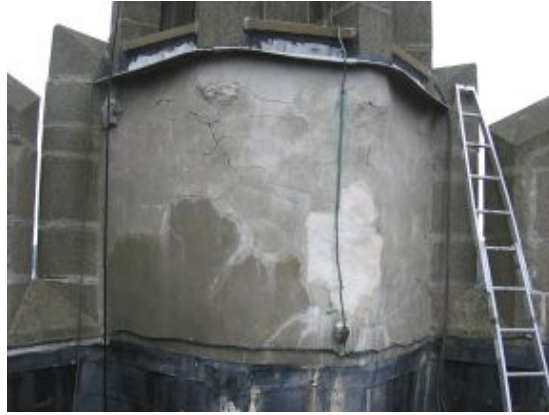
Failed crack and patch repairs in stucco

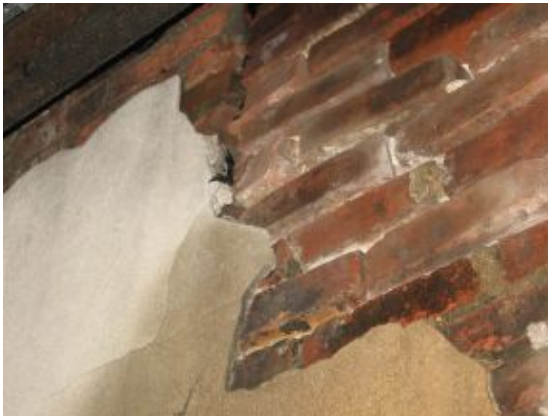
Unsecured stucco separating from the brick substrate
